INTERIOR MODIFICATION OF RESIDENTIAL HOUSING IN FLOOD PRONE AREAS

ZAKIAH HIDAYATI^a, MAFAZAH NOVIANA^a and MUHAMMAD FADZILLAH
ROSYIDI^b

Abstract

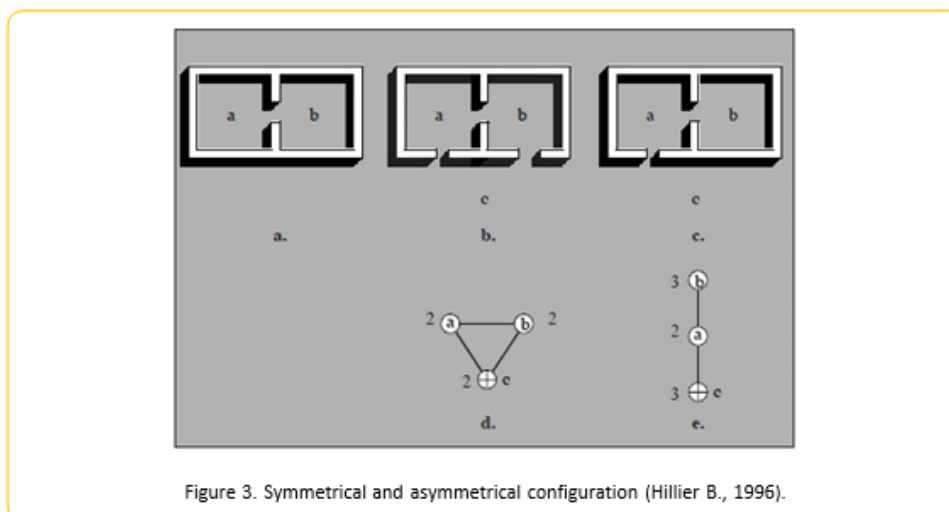
Figure 3. Symmetrical and asymmetrical configuration (Hillier B., 1996).

Figure 3 shows the relation configuration of spaces. d is a j-graph of b, whereas e is a j-graph of c. a does not have any j-graph due to the lack of permeability between the outside and inside spaces. It means any spaces (outside and inside) and their permeabilities/circulations influence the j-graph. The numbers in the j-graph index are contiguous to each space by showing the total depth from each space to the other two. In comparison, d may have created a 'ring' that connects all three spaces, implying that

everyone has a choice of routes to all others. When spotted for each of its spaces, the chart from d is possibly the same, whereas e, b, and c are possibly identical, though a is possibly different.

However, there is a visually appealing way to highlight the key differences between the two spatial patterns before we get to the numbers. It is a j-graph, also known as a justified graph. Initially, we imagine being in a space known as the graph's root or base, represented as a node with a cross inside. Then, using nodes to represent spaces and lines to represent access relations, we align immediately above all spaces directly connected to the root and draw in the connections using nodes to represent spaces and lines to represent access relations.

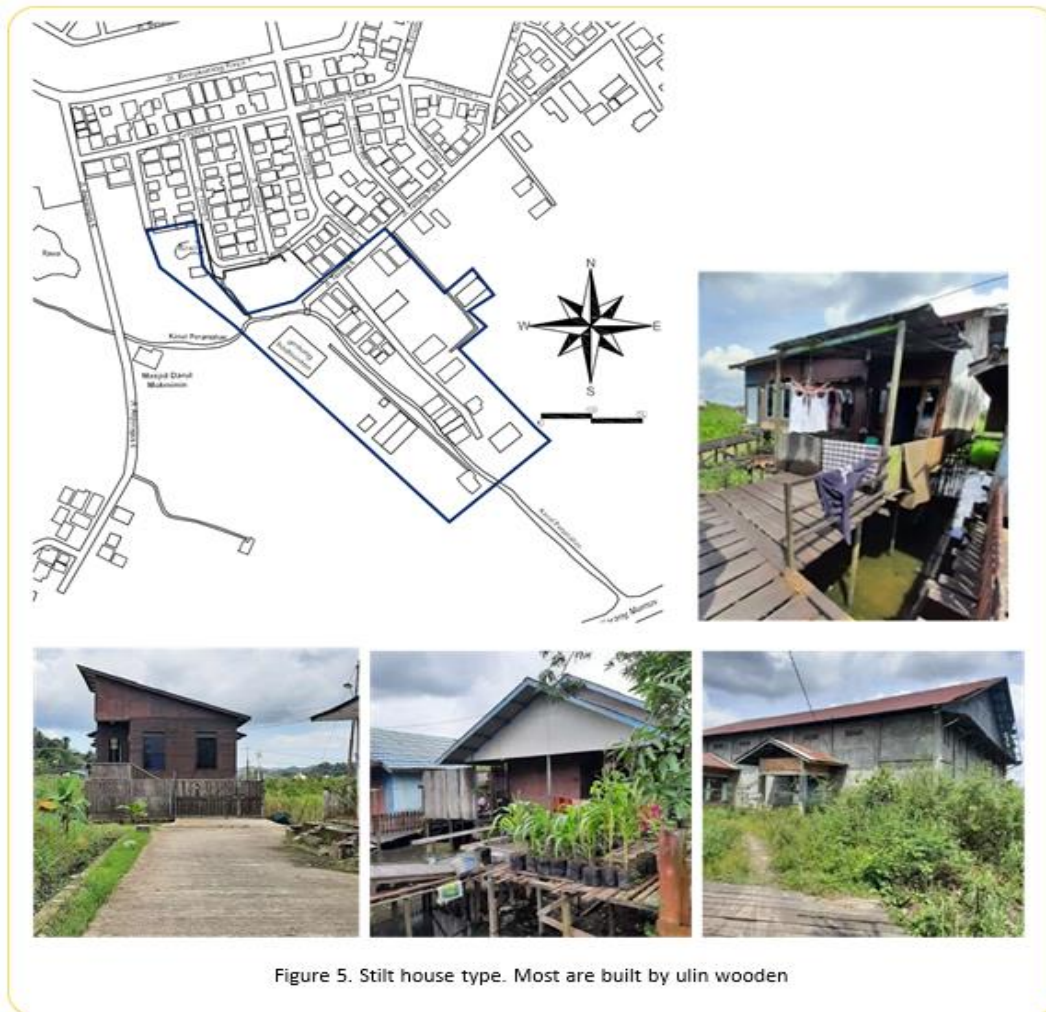
The roofs of the dwelling house are built with wooden construction. The zinc roofs cover most houses with a standard slope of 25-30 degrees. In almost all houses, the attic space is used for electrical wiring. Very few houses use attic rooms for storing goods or occupants' activity space. The attic room and mezzanine use are flexibly applied in wooden buildings without renovating the house.

The wooden stilt house has the potential for interior modification by raising floors, making mezzanine floors, and converting attic spaces. Timber as a main building material is a part of the answer to beat the challenges of environmental and sustainability issues (Karjalainen, Ilgin, Metsäranta, & Norvasuo, 2021). Adding additional wooden floors might make residential districts more appealing (Karjalainen, Ilgin, Metsäranta, & Norvasuo, 2022).

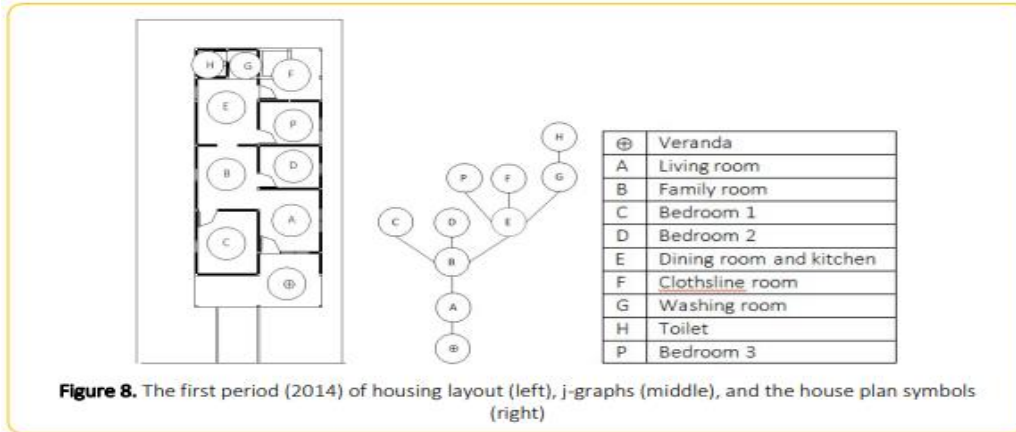
The authors interviewed the house's owner so researchers could comprehend the interior transformation. Figure 8-12 chronologically depicts five different adaptations of the sample wooden house. During the second period, this wooden structure was extensively renovated. Depending on the needs of the occupants and the frequency of flooding, the residence was rehabilitated multiple times.

The first-period house plan consists of ten rooms and meets the family's needs. When the flood reached the community, the proprietor decided to convert the new elevated floor into three new spaces (clothesline room, dining room, and kitchen).

Table 3 describes the summary of j-graphs in the wooden stilt house's first period as a data representation (figure 8). The spaces represented all rooms in the building's interior in the same period. All periods had the summary of j-graphs, but the authors resumed the summary recapitulation for the second to fifth periods (table 4) based on figures 9-12.

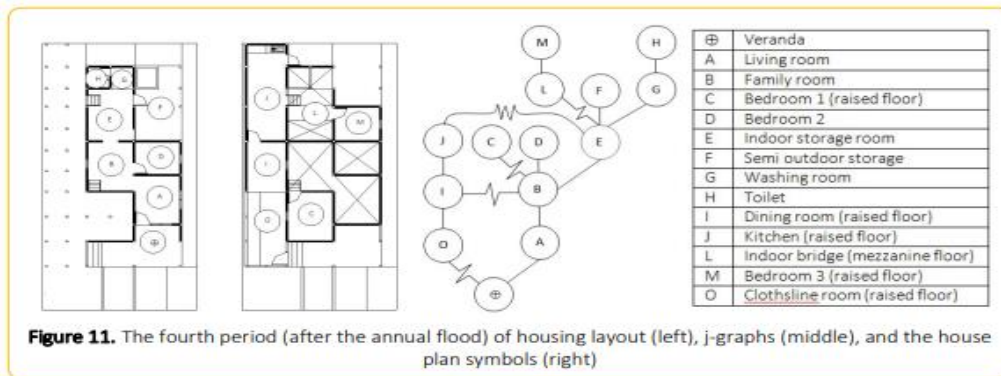
In the fourth period, the house was renovated to add a new bedroom. The new bedroom was on the mezzanine floor (room M) to avoid wetness during floods. Under the mezzanine level, the owner created semi-outdoor storage to keep old stuff underneath. The position of room M needed stairs and a path to access bedroom 3. The owner installed an indoor 'bridge' as a path to the new room. The different levels of the floors created a void in room E above. Room B (family room) and room E were the most integrated rooms in this period.

In contrast, room M (bedroom 3) was the most isolated room. Based on j-graphs in the fourth period, the safe space was the cloths-line room (The outdoor laundry room was located separately), master bedroom, dining room, kitchen, indoor bridge, and bedroom 3. All those space spaces were created incrementally due to the floods.
